**Flood Control Project Maintenance  
Levee Inspections**

**Fall 2014 Levee Maintenance Deficiency Summary Report**

**Butte County Department of Public Works**

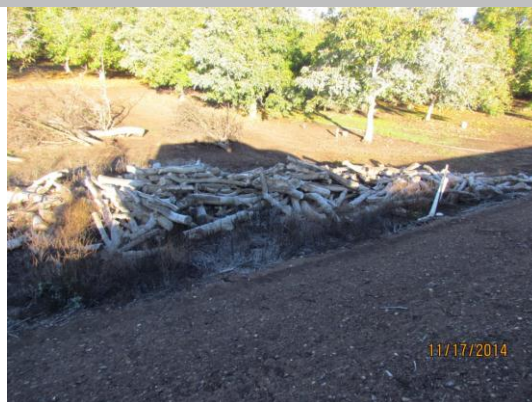
Photo 1 of 1 : FA\_2014\_NA0003\_64\_23\_20141118\_00007.jpg

LM Start	1.32	Rating **	M	Issue No.	23
LM End	1.32	Issue Type +	En	Location *	N/A
Category	Earthen Levee			GPS Latitude/Longitude	
				Start	End
Item	Encroachments			39.741277 °	39.741277 °
				-121.927485 °	-121.927485 °
DWR ID	DWR_NA0003_01_f_2014_23				
Action/Comments					
Firewood

View of the firewood along the landside toe.

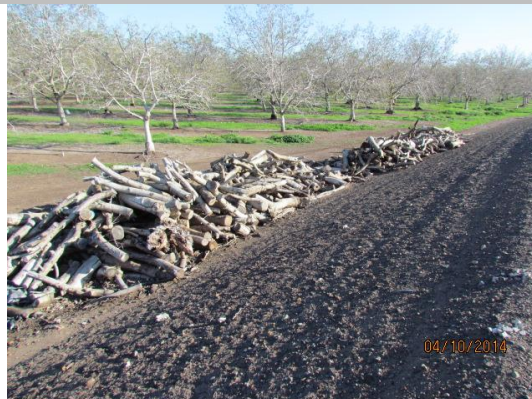
Photo 1 of 1 : FA\_2014\_NA0003\_64\_15\_20141013\_00004.jpg

LM Start	1.74	Rating **	M	Issue No.	15
LM End	1.74	Issue Type +	En	Location *	LS
Category	Earthen Levee			GPS Latitude/Longitude	
				Start	End
Item	Encroachments			39.745718 °	39.745718 °
				-121.923124 °	-121.923124 °
DWR ID	DWR_NA0003_01_s_2014_15				
Action/Comments					
Firewood

View of the firewood along the landside toe.

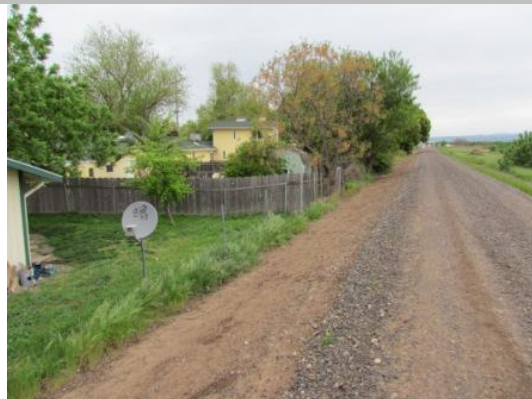
Photo 1 of 1 : FA\_2014\_NA0003\_64\_3\_20141013\_00002.jpg

LM Start	2.06	Rating **	U	Issue No.	3
LM End	2.10	Issue Type +	En	Location *	LS
Category	Earthen Levee			GPS Latitude/Longitude	
				Start	End
Item	Encroachments			39.748330 °	39.748867 °
				-121.918685 °	-121.918533 °
DWR ID	DWR_NA0003_01_s _ 2012_3				
Action/Comments					
Fence

View of the fences along the L/S toe.

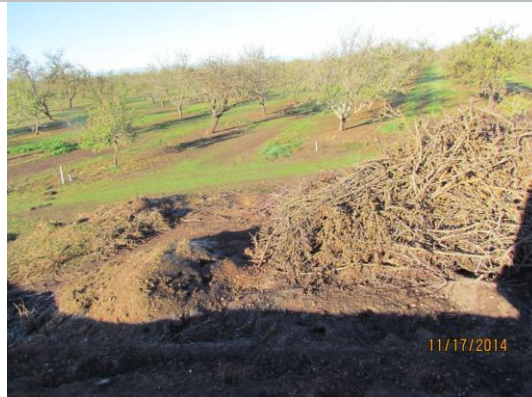
Photo 1 of 1 : FA\_2014\_NA0003\_64\_26\_20141118\_00008.jpg

LM Start	2.66	Rating **	M	Issue No.	26
LM End	2.66	Issue Type +	En	Location *	LS
Category	Earthen Levee			GPS Latitude/Longitude	
				Start	End
Item	Encroachments			39.756022 °	39.756022 °
				-121.914788 °	-121.914788 °
DWR ID	DWR_NA0003_01_f_2014_26				
Action/Comments					
Prunings

View of the prunings along the landside toe.

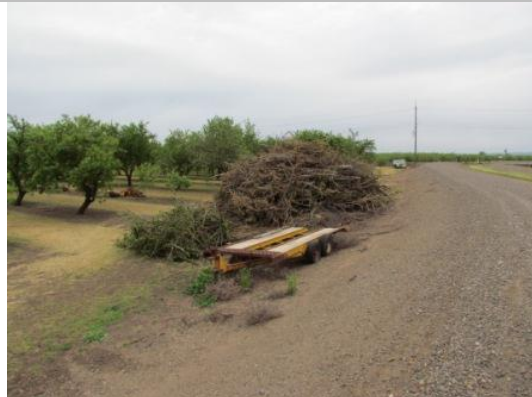
Photo 1 of 1 : FA\_2014\_NA0003\_64\_1\_20141013\_00001.jpg

LM Start	3.00	Rating **	M	Issue No.	1
LM End	3.00	Issue Type +	Ma	Location *	LS
Category	Earthen Levee			GPS Latitude/Longitude	
				Start	End
Item	Encroachments			39.759755 °	39.759755 °
				-121.911160 °	-121.911160 °
DWR ID	DWR_NA0003_01_s_2012_1				
Action/Comments					
Prunings

View of the pruning pile along the L/S toe.

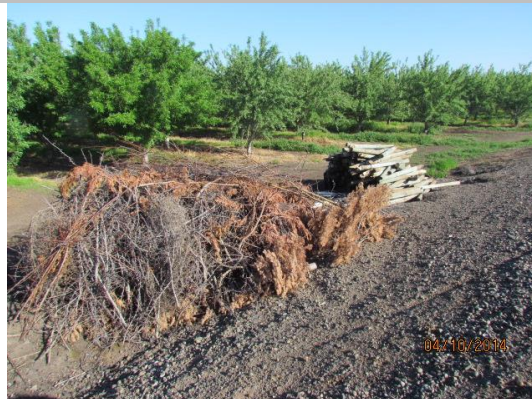
Photo 1 of 1 : FA\_2014\_NA0003\_64\_25\_20141013\_00006.jpg

LM Start	3.10	Rating **	M	Issue No.	25
LM End	3.10	Issue Type +	Ma	Location *	LS
Category	Earthen Levee			GPS Latitude/Longitude	
				Start	End
Item	Encroachments			39.761085 °	39.761085 °
				-121.911048 °	-121.911048 °
DWR ID	DWR_NA0003_01_s_2012_25				
Action/Comments					
Prunings

View of the prunings along the landside toe.

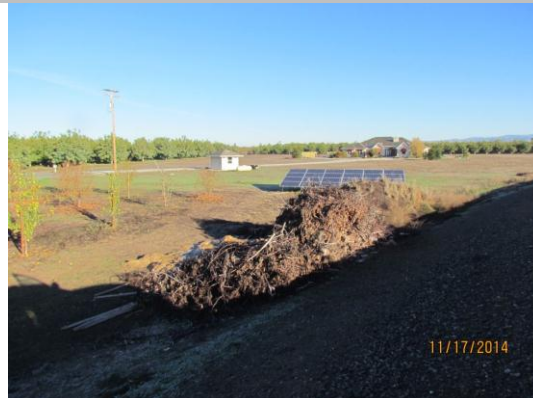
Photo 1 of 1 : FA\_2014\_NA0003\_64\_27\_20141118\_00009.jpg

LM Start	3.33	Rating **	M	Issue No.	27
LM End	3.33	Issue Type +	En	Location *	LS
Category	Earthen Levee			GPS Latitude/Longitude	
				Start	End
Item	Encroachments			39.763993 °	39.763993 °
				-121.909108 °	-121.909108 °
DWR ID	DWR_NA0003_01_f_2014_27				
Action/Comments					
Prunings

View of the prunings along the landside toe.

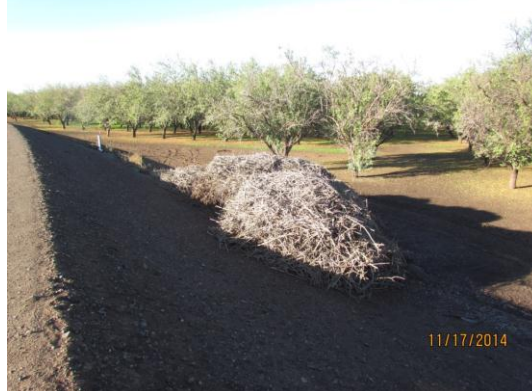
Photo 1 of 1 : FA\_2014\_NA0003\_64\_28\_20141118\_00010.jpg

LM Start	3.99	Rating **	M	Issue No.	28
LM End	3.99	Issue Type +	En	Location *	LS
Category	Earthen Levee			GPS Latitude/Longitude	
				Start	End
Item	Encroachments			39.770502 °	39.770502 °
				-121.901200 °	-121.901200 °
DWR ID	DWR_NA0003_01_f_2014_28				
Action/Comments					
Prunings

View of the prunings along the landside toe.

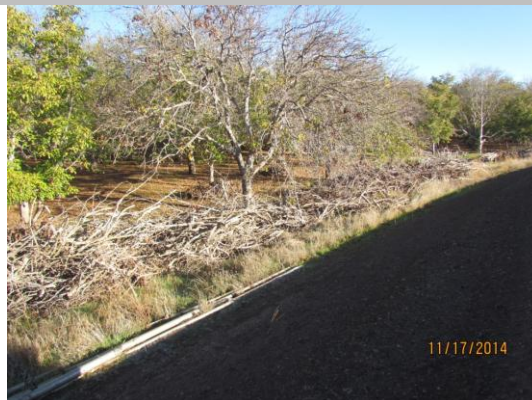
Photo 1 of 1 : FA\_2014\_NA0003\_64\_29\_20141118\_00011.jpg

LM Start	4.13	Rating **	M	Issue No.	29
LM End	4.13	Issue Type +	En	Location *	LS
Category	Earthen Levee			GPS Latitude/Longitude	
				Start	End
Item	Encroachments			39.771843 °	39.771843 °
				-121.899437 °	-121.899437 °
DWR ID	DWR_NA0003_01_f_2014_29				
Action/Comments					
Prunings

View of the prunings along the landside toe.

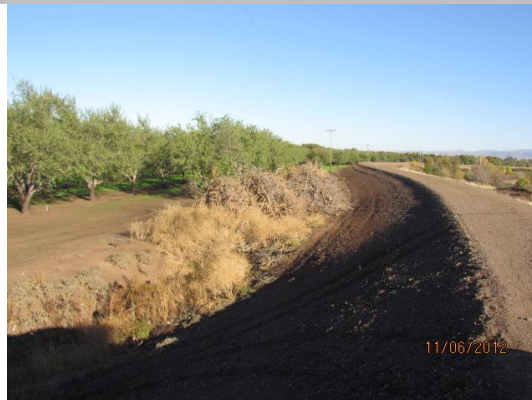
Photo 1 of 1 : FA\_2014\_NA0003\_64\_21\_20141013\_00005.jpg

LM Start	4.58	Rating **	M	Issue No.	21
LM End	4.58	Issue Type +	Ma	Location *	LS
Category	Earthen Levee			GPS Latitude/Longitude	
				Start	End
Item	Encroachments			39.775908 °	39.775908 °
				-121.893947 °	-121.893947 °
DWR ID	DWR_NA0003_01_s_2012_21				
Action/Comments					
Prunings

View of the brush pile along landside toe.

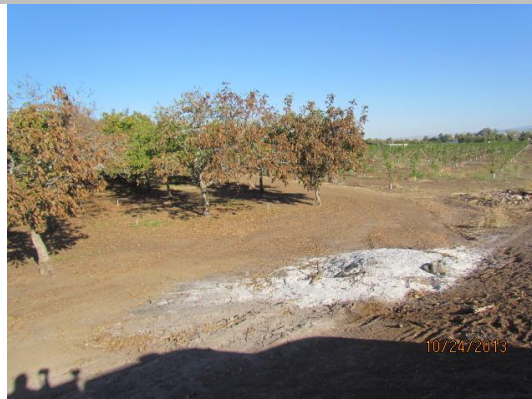
Photo 1 of 1 : FA\_2014\_NA0003\_64\_13\_20141013\_00003.jpg

LM Start	4.91	Rating **	A/W	Issue No.	13
LM End	4.91	Issue Type +	En	Location *	LS
Category	Earthen Levee			GPS Latitude/Longitude	
				Start	End
Item	Encroachments			39.780068 °	39.780068 °
				-121.891469 °	-121.891469 °
DWR ID	DWR_NA0003_01_s_ 2013_13				
Action/Comments					
Prunings

The landowner burned the pruning pile.

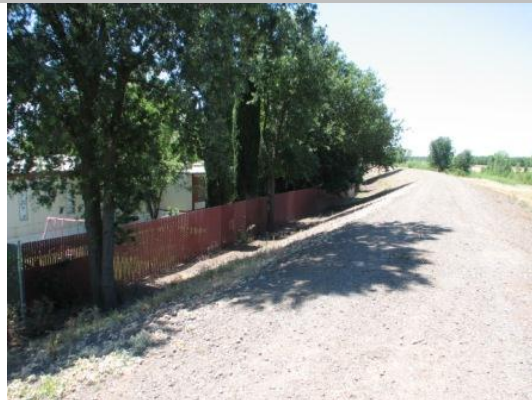
Photo 1 of 1 : FA\_2014\_NA0003\_65\_3\_20141013\_00002.jpg

LM Start	1.58	Rating **	U	Issue No.	3
LM End	1.90	Issue Type +	En	Location *	LS
Category	Earthen Levee			GPS Latitude/Longitude	
				Start	End
Item	Encroachments			39.782773 °	39.778972 °
				-121.888178 °	-121.891563 °
DWR ID	DWR_NA0003_02_s_2012_3				
Action/Comments					
Fence

View of the fence along the landside toe of the levee.

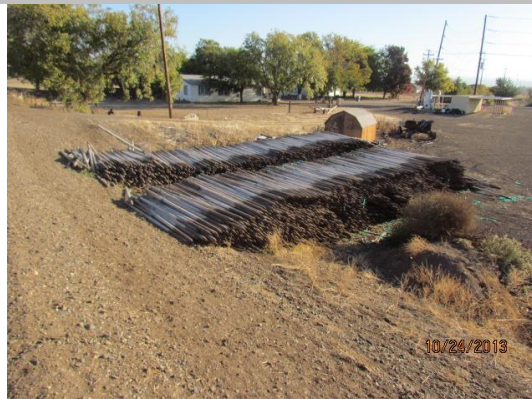
Photo 1 of 1 : FA\_2014\_NA0003\_65\_1\_20141013\_00001.jpg

LM Start	2.90	Rating **	M	Issue No.	1
LM End	2.90	Issue Type +	En	Location *	LS
Category	Earthen Levee			GPS Latitude/Longitude	
				Start	End
Item	Encroachments			39.767841 °	39.767841 °
				-121.901534 °	-121.901534 °
DWR ID	DWR_NA0003_02_f_2013_1				
Action/Comments					
Material

View of the tree stakes along the landside slope and toe.

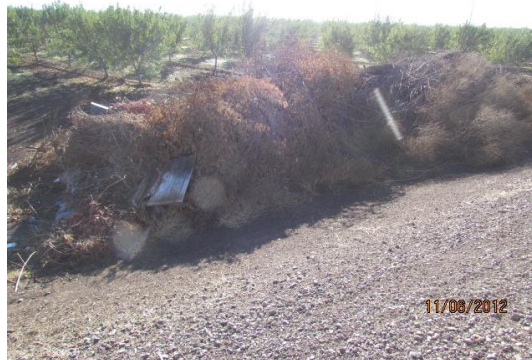
Photo 1 of 1 : FA\_2014\_NA0003\_65\_5\_20141013\_00003.jpg

LM Start	3.42	Rating **	M	Issue No.	5
LM End	3.42	Issue Type +	Ma	Location *	LS
Category	Earthen Levee			GPS Latitude/Longitude	
				Start	End
Item	Encroachments			39.763208 °	39.763208 °
				-121.908517 °	-121.908517 °
DWR ID	DWR_NA0003_02_f_2012_5				
Action/Comments					
Prunings

View of the brush pile along landside toe.

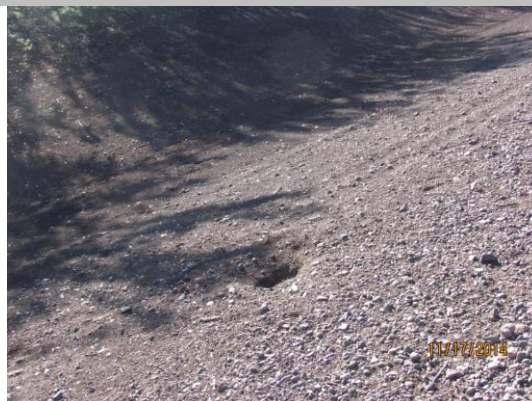
Photo 1 of 1 : FA\_2014\_NA0003\_65\_12\_20141118\_00010.jpg

View of the rodent holes along the landside slope.

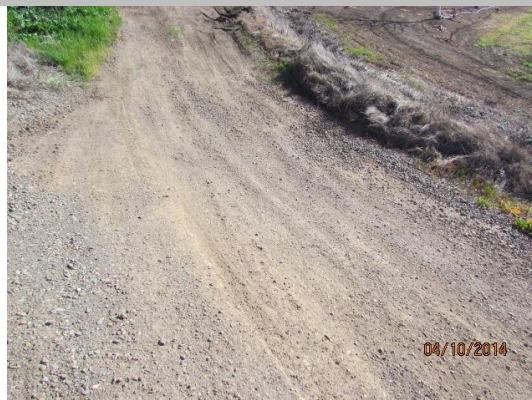
Photo 1 of 1 : FA\_2014\_NA0003\_65\_10\_20141013\_00008.jpg

LM Start	3.63	Rating **	M	Issue No.	10
LM End	3.63	Issue Type +	Ma	Location *	LS
Category	Earthen Levee			GPS Latitude/Longitude	
				Start	End
Item	Slope Stability			39.760531 °	39.760531 °
				-121.910293 °	-121.910293 °
DWR ID	DWR_NA0003_02_s_2014_10				
Action/Comments					
Repair the levee slope damaged by vehicle traffic and prevent access where possible.

View of the vehicle erosion along the waterside slope.

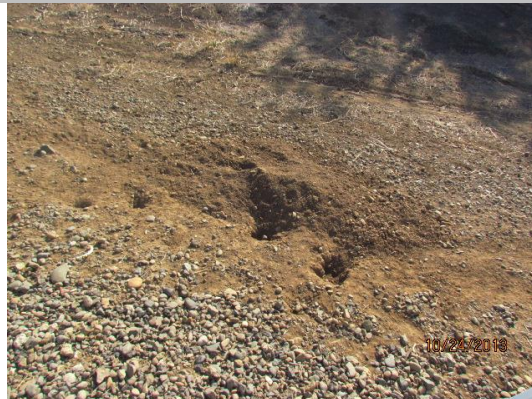
Photo 1 of 1 : FA\_2014\_NA0003\_65\_8\_20141013\_00006.jpg

View of the rodent holes along the landside slope.

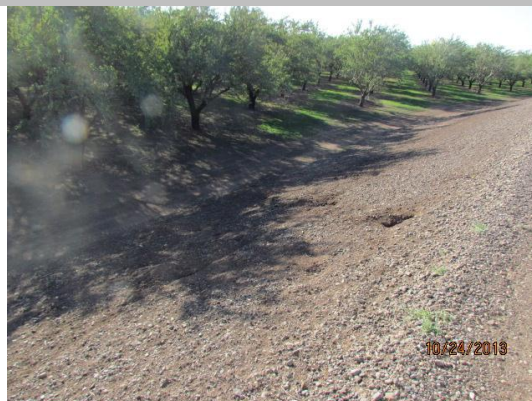
Photo 1 of 1 : FA\_2014\_NA0003\_65\_9\_20141013\_00007.jpg

View of the rodent holes along the landside slope.

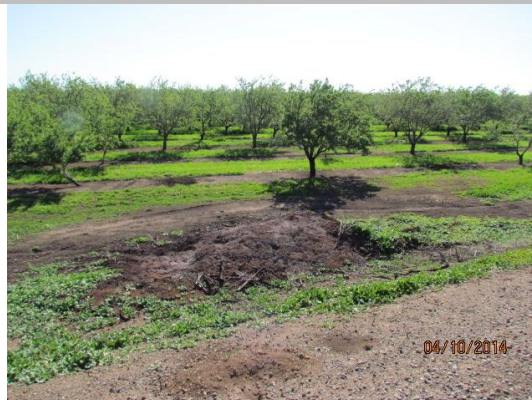
Photo 1 of 1 : FA\_2014\_NA0003\_65\_7\_20141013\_00005.jpg

View of the removed prunings from the landside toe.

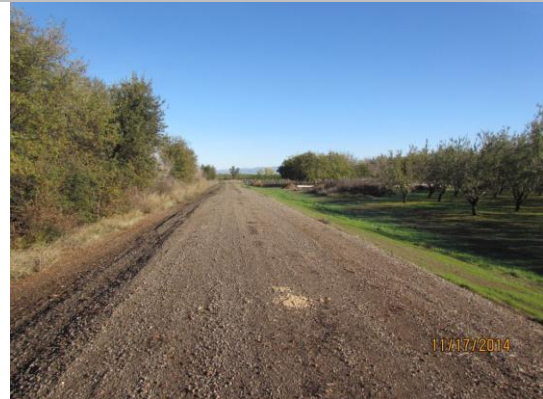
Photo 1 of 1 : FA\_2014\_NA0003\_66\_17\_20141118\_00001.jpg

View of controlled vegetation on both slopes.

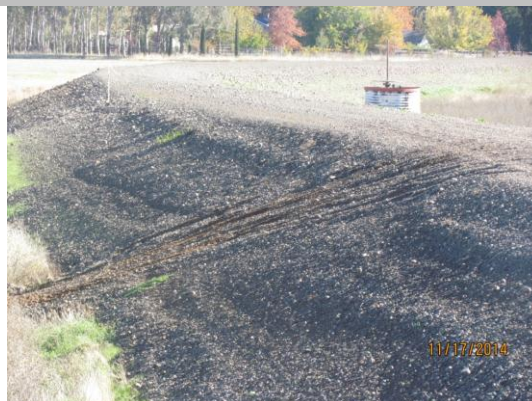
Photo 1 of 1 : FA\_2014\_NA0003\_67\_3\_20141118\_00002.jpg

View of the erosion caused by motorcycles on the land side slope.

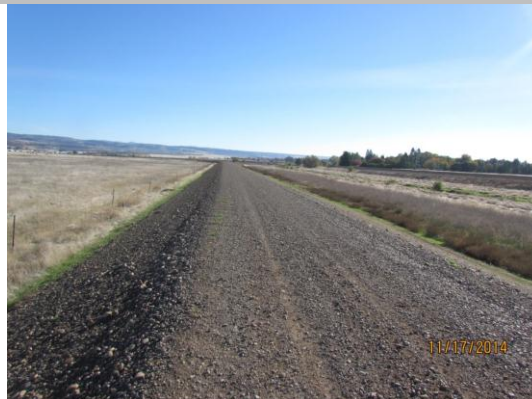
Photo 1 of 1 : FA\_2014\_NA0003\_67\_12\_20141118\_00003.jpg

View of controlled vegetation on both slopes.

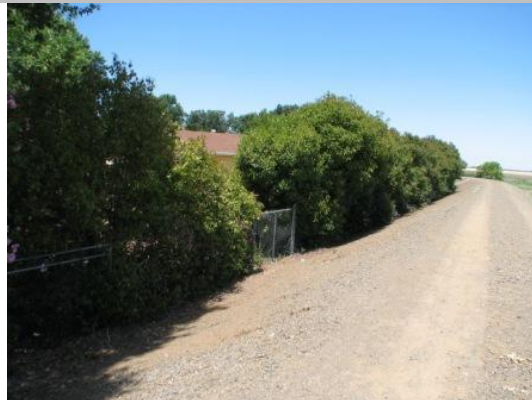
Photo 1 of 1 : FA\_2014\_NA0003\_68\_1\_20141013\_00001.jpg

View of the fence and trees along the landside toe of the levee.

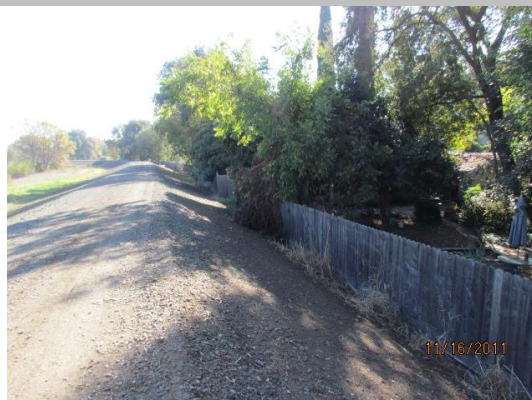
Photo 1 of 1 : FA\_2014\_NA0003\_68\_3\_20141013\_00003.jpg

View of the fence along the L/S toe.

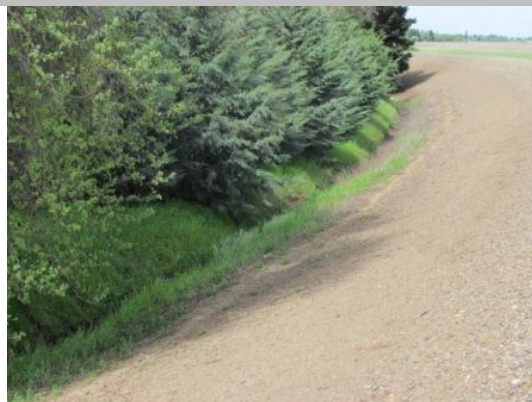
Photo 1 of 1 : FA\_2014\_NA0003\_68\_2\_20141013\_00002.jpg

LM Start	1.32	Rating **	M	Issue No.	2
LM End	1.40	Issue Type +	En	Location *	LS
Category	Earthen Levee			GPS Latitude/Longitude	
				Start	End
Item	Encroachments			39.778003 °	39.778378 °
				-121.856403 °	-121.857953 °
DWR ID	DWR_NA0003_04_s_2012_2				
Action/Comments					
Ditch

View of AG ditch at the L/S toe.

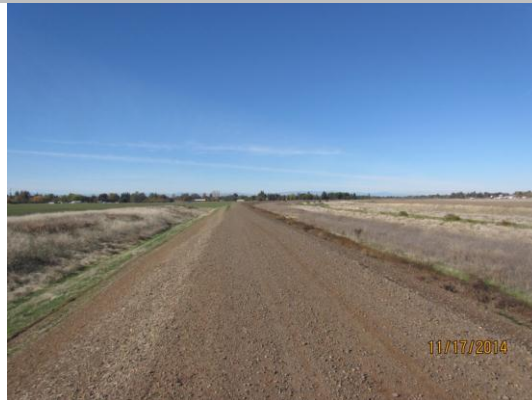
Photo 1 of 1 : FA\_2014\_NA0003\_68\_17\_20141118\_00004.jpg

View of controlled vegetation on both slopes.
